## EFFECT OF HIGH TEMPERATURE ON COMPOSITE AS POST ENDODONTIC RESTORATION IN FORENSIC ANALYSIS-AN IN VITRO STUDY

**Aim:** The present study was done to evaluate and compare the effect of different temperatures (400°C, 800°C and 1000°C) on Composite as post endodontic restoration using Naked eye, Digital camera and Radiovisiography (RVG) in forensic analysis. **Methodology:** An in vitro study was conducted on 42 human teeth with composite as post endodontic restoration exposed to three temperature ranges: 400°C, 800°C and 1,000°C. **Results:** Composite material studied in the present research offered great resistance to high temperatures, without exhibiting considerable macrostructure variation, in such a way that physical changes (dimensional stability, fissures, cracks, fractures, texture, color, carbonization and incineration) can be identified and associated to each specific temperature range. **Conclusion:** Dental tissues and materials offer great resistance to the effect of high temperatures. Moreover, they present specific changes (color, texture, fissures, cracks fractures, fragmentation) which might contribute to the process of identifying a corpse, or burned, incinerat

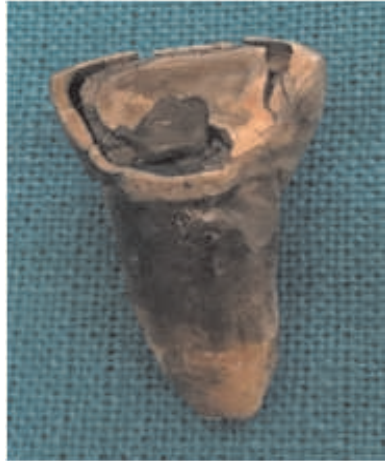
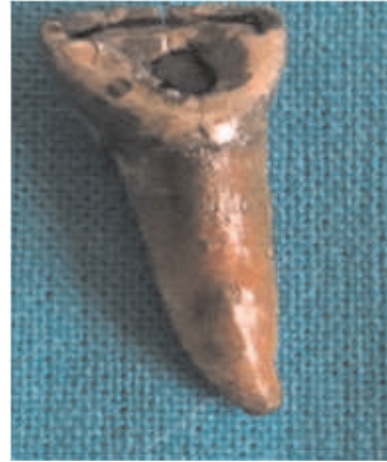
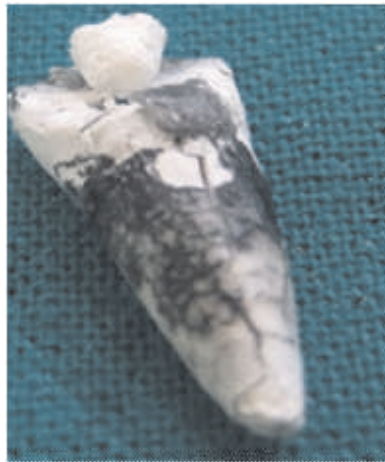
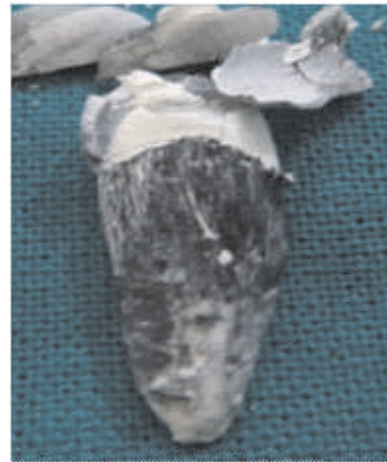
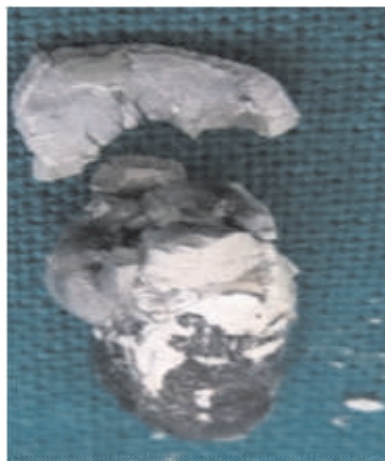
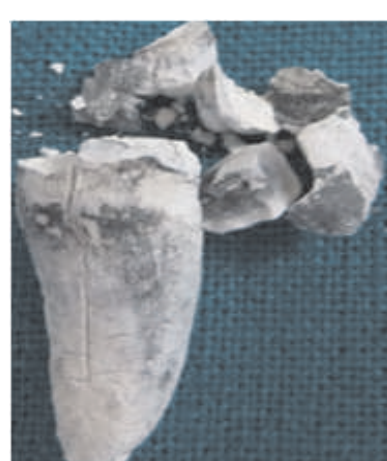
Figure 1: Digital Camera evaluation of the samples at different temperatures

Temperature	Naked Eye Evaluation	Digital Camera Evaluation	Radiovisiography
<b>Group A ( at 400°C)</b>	The crown of the samples were intact but had horizontal and vertical fracture lines on them. Only in one sample a portion of coronal tooth structure was lost. There was evident change in color of the teeth ranging from light to dark brown, while the composite restorations had dark brown color. The composite restorations although remaining whole had undergone marginal retraction.	The teeth were intact and except in one sample which had coronal portion fractured and detached. There were fracture lines on the crown portion of the teeth. The composite restorations turned to dark brown and presented marginal maladaptation as well as superficial cracks and fissures.	The teeth showed fracture lines. Composite restorations were observed as radiopaque. They were intact but showed marginal retraction

<b>Group B ( at 800°C)</b>	The crowns of the teeth had shattered into pieces whereas root remained as whole. The surface color of the teeth was chalky white while its interior was blue-grey. There were cracks in the roots but the composite restorations were in place. Composite restorations were chalky white. Even though the restorations maintained their shape, they showed marginal retraction.	The color of the root surfaces was bluish grey with chalky white patches. The crowns and composite restorations were chalky white. There was cracking and separation between enamel and dentine as well as between dentine and fillings, while the roots remained intact with deep cracks.	The crowns were disintegrated. There were deep cracks on the teeth. The composite restorations were observed as radiopaque with altered shape and marginal retraction.
<b>Group C ( at 1000°C)</b>	The crowns had shattered and after handling the crown disintegrated completely while the roots were intact with greyish white color. There were numerous deep cracks and microfractures on the remaining tooth structure. The composite restorations were totally dislodged due to fragmentation of the crown.	The sample fractured into chalky white and grey fragments. The root surface showed fracture lines. The composite restorations were dislodged and severely altered in shape and displayed white color.	The crowns were totally shattered with radiolucent fracture lines in the remaining tooth structure. The radiopaque composite restorations had dislodged due to shattering of the crown hence could not be differentiated at this temperature in the radiograph. Few samples had composite restoration in place but they showed great alteration in shape.

In this study, in all the teeth fissures or superficial cracks were observed at 400°C, which turned into deep cracks to fracture lines at 800° C followed by fragmentation of crown portion of teeth at 800° C to 1000° C (Figure 1). The teeth got disintegrated when handled at 1000°C. These findings were similar to as

While dealing with composite resin, the fact that draws attention is the change in color.<sup>12</sup> In the present study at 400° C, the composite restoration turned to brown hue and presented mild marginal retraction as well as superficial cracks and fissures which was due to the acrylic matrix combustion and is in concurrence with the study conducted by Vazquez L et al<sup>12</sup> and Moreno S et al<sup>14</sup>. The marginal contraction apparent in the composite restoration is probably due to the loss of the organic matrix as described by Moreno S et al<sup>14</sup>. The resin restoration on a digital radiograph appeared to be intact and could be easily identified. Marginal retraction between the restoration and tooth structure was observed on the radiograph.
