“VERTICAL ROOT FRACTURE”- A DILEMMA REVISITED

Diagnosis of vertical root fracture in an endodontically treated tooth presents with various difficulties. The diagnosis of such a fracture is a challenge to the clinician since it is based on subjective parameters. There are, however, many specific clinical and radiographical signs which, when present, can alert clinicians to the existence of such a fracture. Various methods to clinically diagnose vertical root fracture include conventional methods such as illumination, periodontal probing, staining, direct visual examination and newer techniques such as cone beam computed tomography, optical coherence tomography. The management of a vertical root fracture has always been considered a difficult task for the endodontist. This article provides an insight into the various methods of diagnosis and treatment strategies for the vertical root fracture.

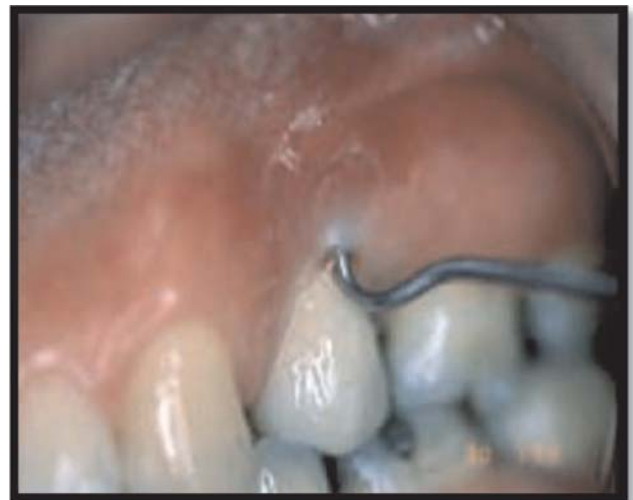
Figure 2: Deep narrow pocket in maxillary premolar

- A common feature of vertically root fractured teeth is the development of deep, narrow, isolated periodontal pockets (Figure 2). When the

periodontal probe is inserted into this type of periodontal pocket, it is tight within the pocket, and the periodontal probe's movement from side to side is restricted. The probing pattern for a tooth with a vertical root fracture is different from that seen in teeth with periodontal disease, where the pocketing is fairly consistent in depth around a large part of the tooth. Deep probing in two positions on opposite sides of the infection is almost pathognomonic for the presence of a fracture.⁴

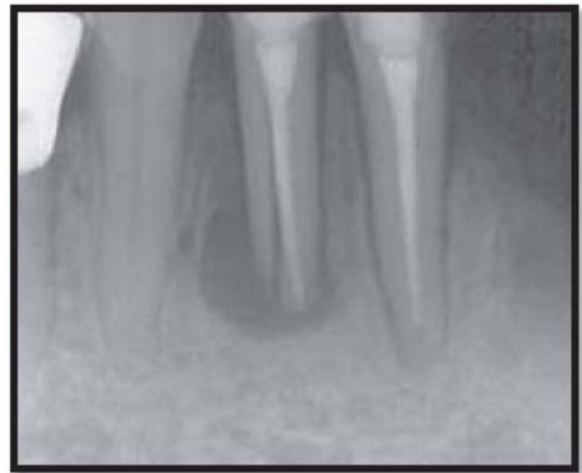
Figure 4: Separation of root fragments

- Separation of root fragments: When separation of root fragments occurs, the root fracture is clearly visible. Once separation of fragments has occurred, proliferation of granulation tissue often results in the rapid movement of the fragment away from the remaining root⁷ (Figure 4).
- Fracture lines along the root or root filling: Direct

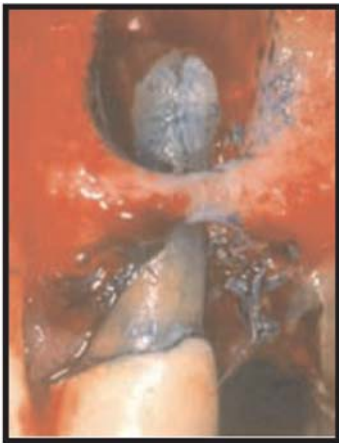
Figure 6: Methylene blue dye used to detect vertical root fracture under direct visualization

Direct observation of the fracture is the only sure way to confirm the presence of the fracture in many cases. Gentle retraction of the soft tissues in the region of the suspected fracture line with a flat plastic or other instrument (under anaesthetic if required) may be sufficient to view the fracture on the root surface. Location of the fracture can be assisted by passing a sharp probe lightly over the tooth surface. A 'clicking' sound can be heard as the probe is passed over the fracture line.⁴ Where this is not possible, reflection of a small flap is recommended in order to view the root and confirm the presence of a fracture (Figure 6).
